**Atlantic Shore Line Railway
Locomotive 100**

Curatorial Report No. 1
21 October – 31 December 2006
by *Donald G. Curry, Interim Shop Manager*
Seashore Trolley Museum

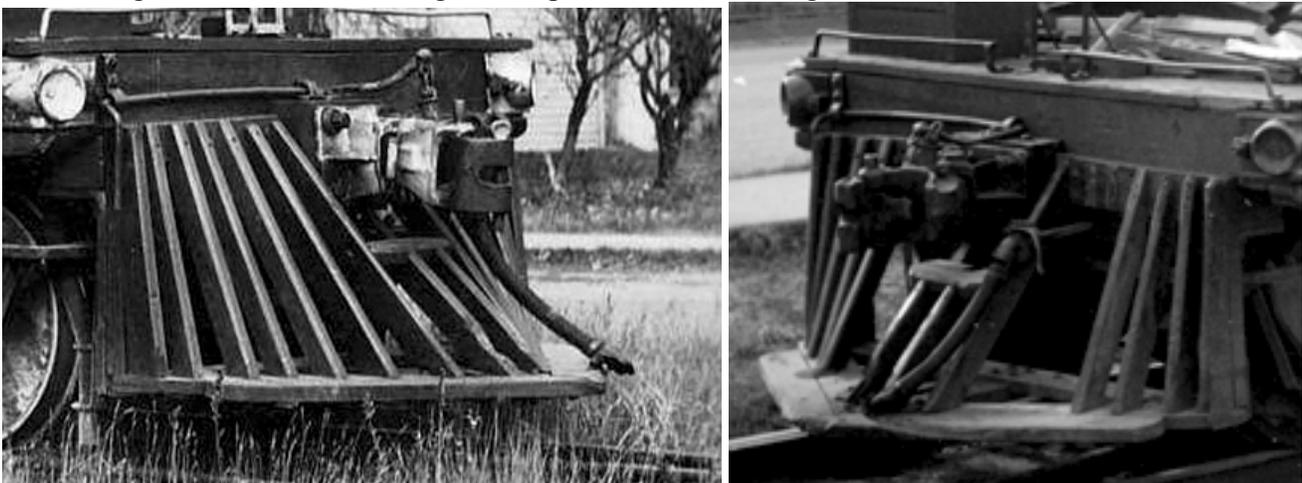
Pilot’s teeth – Over the years its oak pilots lost some of their ‘teeth’. The no. 1 pilot is totally missing except for one of the mounting brackets. We have only four out of the total of 14⁸ ‘teeth’, the two mounting brackets and enough of the bottom frame, center piece and top mount to draw plans for a new one. Apparently at the same time, the no. 1 end sill and pilot assembly were removed and no trace of the wood remains. It does appear that we have the original hardware including the coupler and its mounting.

Pilots on YUCo 100 1930s and 1949

The no. 1 end pilot does show in the photo of 100 on a trailer in 1949 as it was being moved to the then Seashore Electric Railway. Some of the teeth are missing. We did find the right-hand top support (2 x 6 in. oak) which fastens (with two lag screws and one through-bolt) to the pilot support beam. All others have disappeared. A very important piece we found was the bottom crosspiece, which extends all across the back of the pilot. Both ends are half-lapped so you can tell the angle of the horizontal bottom diagonal pieces. Also, to it is bolted a piece which extends forward on the bottom to the point of the pilot, so between all, we have a pretty good idea of how it is shaped. There are traces of the screws which fastened the teeth so we can figure the spacing from that. In the middle is what gives the appearance of a fence stile. This consists of two 'teeth' with a horizontal flat between them with a stiffening tie-rod between. This fits under the coupler.

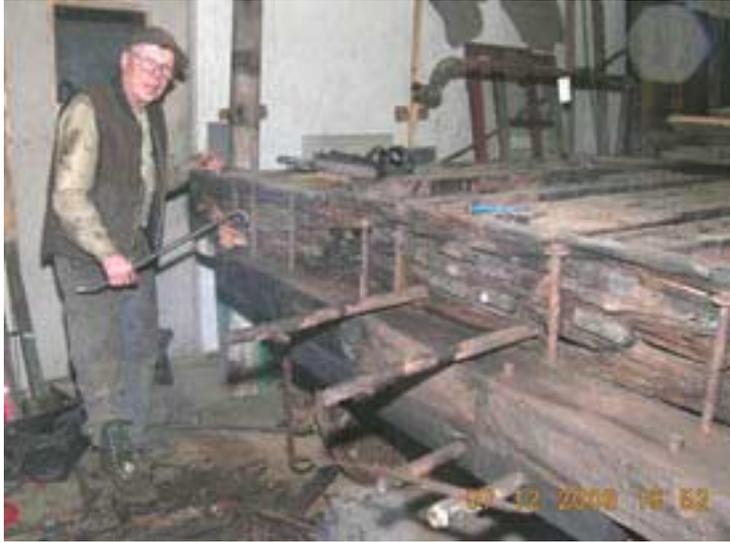
The end sill/pilot support assembly on the no. 1 end is totally missing although it did arrive on the locomotive, albeit deteriorating. On the no. 2 end it was there, collapsing on to the truck frame with the through bolts

holding it together, largely rusted beyond re-use. There is just enough full cross-section wood to get the original dimensions.

Removing no. 2 end sill assembly

When we removed the remains of the sill on the no. 2 end we were pleasantly surprised to find all of the tenons remaining. The only one missing was on the left sill, replaced by STM. Some of the tenons are soft and will have to be stiffened by injecting them with epoxy resin.

Interestingly the pilot support beam was in near-perfect condition with splits only on one end. These may have been caused by the bolts holding the 'sandwich' together dragging on the truck frame when the truck swiveled. From its dimensions and the fact that it looks like it was creosoted leads one to believe it may have been a railroad tie. The beam under that which backs up the coupler blocks was also in similar condition.

It was impossible to remove the assembly without cutting some of the bolts with the Tiger Saw. Most, if not all, have deteriorated to the point that most of their original strength is gone, so they will all have to be replaced.

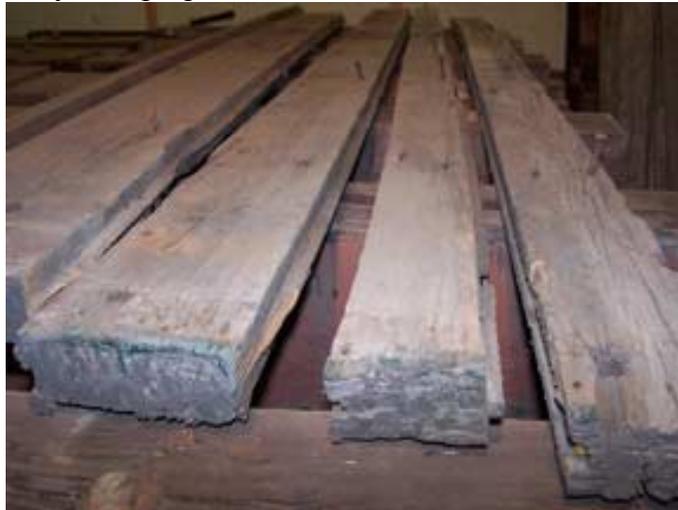
These boards must have been applied without being fully dried because between each one was a 3/8 in. space which developed after the wood dried. Because of the wide spaces that must have formed later, we have the feeling that Laconia was in a hurry to deliver the car or didn't have a dried supply of that thickness wood in stock when 100 was built so it went on 'wet' ("stump dried"!). We also noted cracks as well running down the side sill(s?) of both 100 and 102. In fact, 100's shows up in the 1907 photo. What kind of guarantee came with the car??

We were surprised that they were red oak instead of white, which is a bit more durable. This didn't become obvious until Phil Morse accidentally split some which didn't cooperate when pried upon. We preserving most of the floor boards in the cab especially those in front of the controllers. There the floor is significantly worn by the feet of a couple of generations of motormen. (or are they 'engineers'?) Since we aren't trying to make 100 'show-room fresh', this wear is a significant 'artifact'. There are also prints and bolt holes for the two different controllers the car carried: early K-28F and 'present' K-35G.

1 7/8 in. tongue-and-groove decking laid out for re-installation

We will have to examine every piece to see if we can re-use it. We have ordered enough new decking to replace any pieces we can't save as well as the missing area at the right-hand door. Since they are all different widths it will be tricky to fit them in so they look proper.

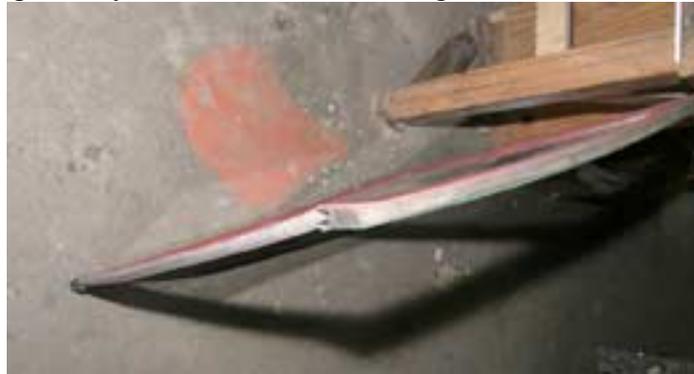
Sash and Doors. Of the sash, without a very careful examination, it appears that eight of the ten will require little repair while one has warped so badly it will have to be remade. It appears that originally all 10 had one piece of glass but later they were divided horizontally into two panes. We will probably go back to the single piece of DSB glass.²³ One of the doors also had had a home-made divider in its sash. The hardware appears to be hardware store variety but probably was on the car for a long time so, if it works, it can be re-used.

The sash were raised with leather tabs held on with small bronze castings. Some are missing and will have to be re-cast. There are a few of the anti-rattler springs left so these also will have to be re-made.

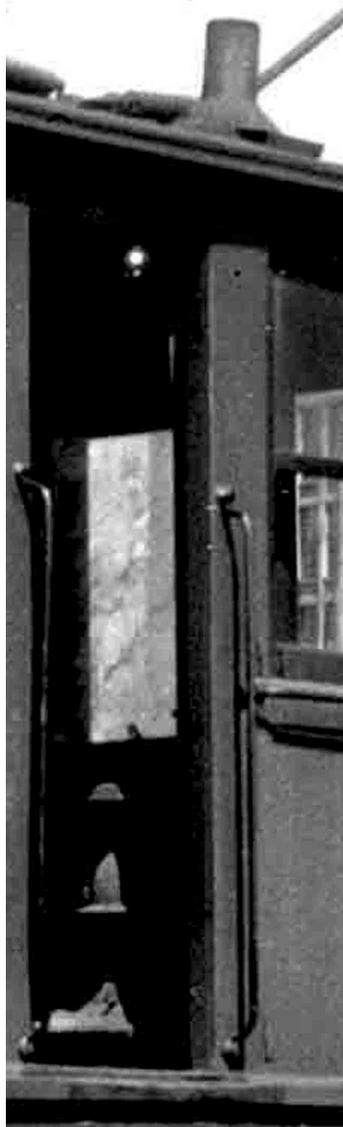
Stove – There are two shots of through the cab door, each of which definitely show a small pot-bellied coal stove. There is also a very simple open-topped smoke jack on the roof. We also found coal in cracks behind where the stove rested. When 100 came to SERy in 1949 the smoke jack was in place but nobody can remember if there was a stove. It should be possible to replace it. We can't find evidence of a coal bin so probably they just used a bucket. (hod?)

Pot-bellied stove 1948 or 1949
Sanford

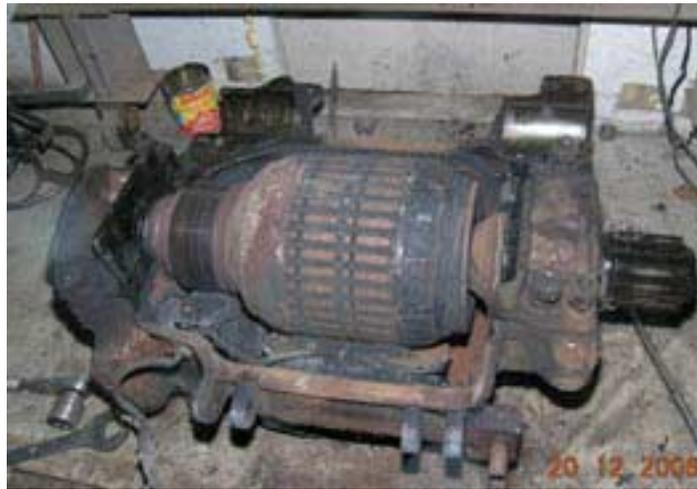
Inverted and opened GE-80A Traction Motor
Armature bearing caps and pinion still installed

Unfortunately we discovered that many of 100's motor bolts had probably not been turned for the better part of a century so many required the 'gas wrench' which broke the rust 'bond', after which many could be turned by the use of the 1 7/8 in. socket with extension. Some required the use of a 'slugging' wrench and others had to be cut off. In this case, if great care is used with the cutting torch, the nut only is destroyed and the threads on the bolt remain untouched.

On motors 2 and 3 the armature bearing cap on their commutator end had a long-standing crack which will have to be nickel-welded. It is interesting that the crack formed on that end which has less strain than the gear end.

We will turn off the corroded bolt heads and weld on square nuts, machining them down to the same dimensions as they were originally.

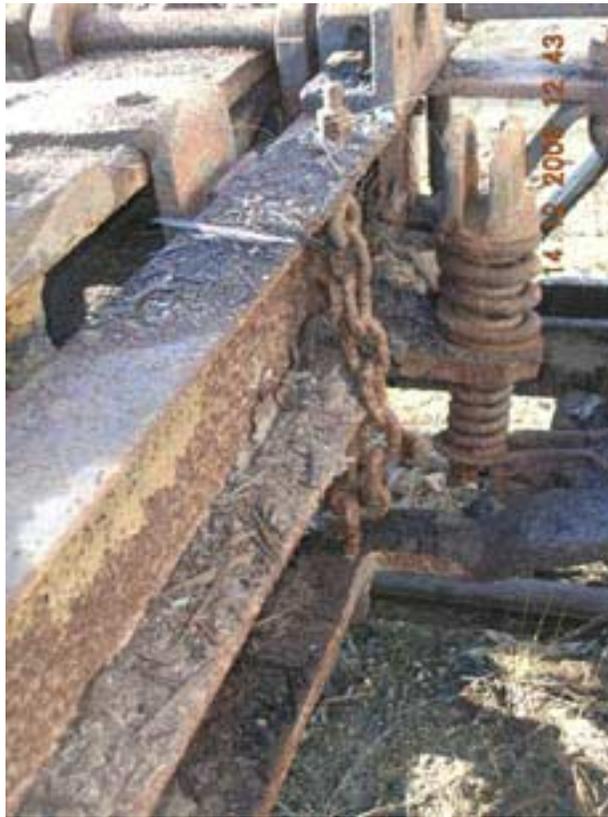
Truck detail showing transom, motor mount bracket and brake beam with suspension chain and lots of corrosion and crud.

With the trucks out from under the body and the motors removed it is now possible to examine just what condition they are in. Fortunately they are complete, the only ‘missing’ components are the slack adjuster and brake levers that broke on one truck and they are in the pile of parts. The brake shoes are a larger sized shoe for which we have no spares but all have good wear; only one is worn somewhat crooked. The springs are likewise all there. We can’t tell about the large coil springs on the equalizers which sit in sockets. They may be corroded in that area. Some of the four full-elliptic bolster leaf springs may be corroded but it is hard to tell without further disassembly.
