Atlantic Shore Line
Locomotive 100
Curatorial Report no. 2
1 – 16 January 2007
by Donald G. Curry, Interim Shop Manager
Seashore Trolley Museum

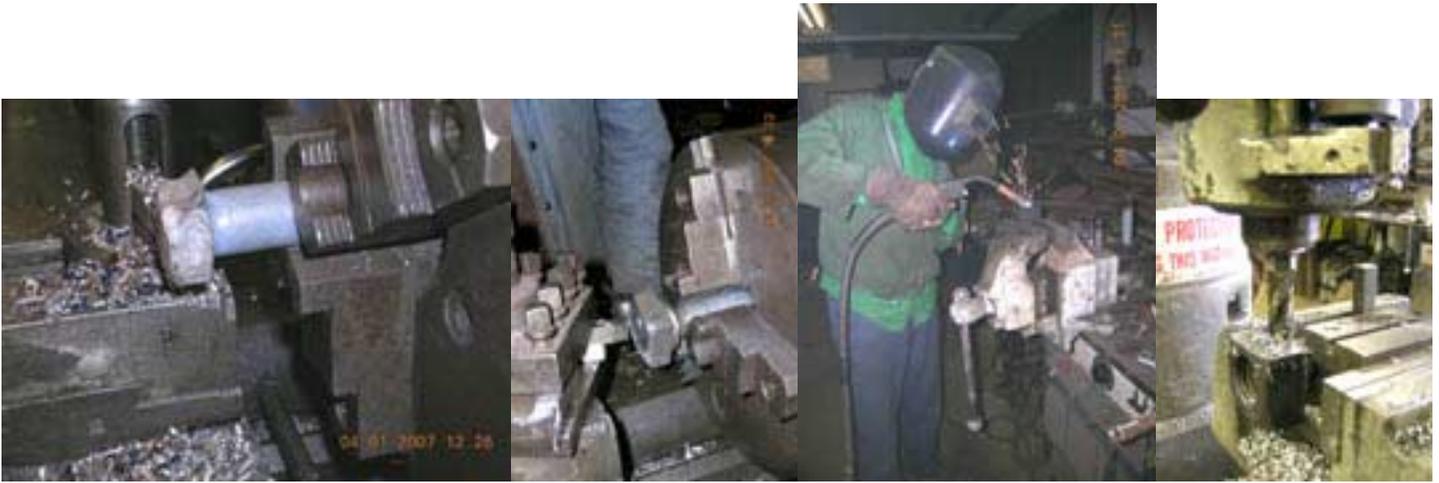
Correcting eroded heads – The heads of 13 of these original bolts had corroded so badly that it was necessary for **Dean** to make new ones.³ Using our American lathe, he turned the remains of the head round; then turned on a 1 1/2 in. coarse thread. On to that he screwed a large 1 1/2 in. square nut (of which we had quite a number in stock). This was then tack-welded in place. He then turned the shoulder on the bottom of the new head. The last steps were to:

Remaking the square-headed motor frame bolts
Dean Look welding

1. Mill the head 1 7/8 in. sq. with the Bridgeport milling machine.
2. Mill the thickness of the head just slightly higher than the original had been
3. Turn a chamfer on the top of the head to match the original
4. Fill the hole in the top of the head with weld
5. Mill the welding flat.

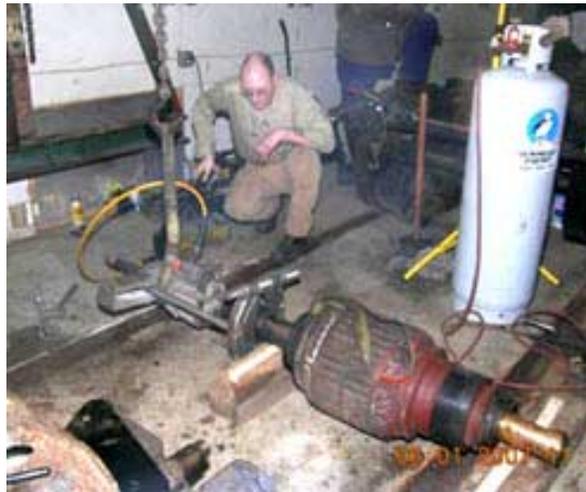
Don Landry pulling the pinion.

We think success came this time because the heat was more concentrated—on one ‘groove’ between the teeth—rather than generally with the gas flame we used before. That method apparently allowed the heat to sink in to the shaft, allowing it to expand with the pinion. We do have some concern that the heat treatment of the pinion may have been affected but other ‘opinions’ are that we’re not going to put the service on it that would wear it out anyway.

As we wondered why this pinion was so resistant, Don ‘opined’ that it was probably installed using too much heat rather than the gentler method of placing it in boiling water, that we traditionally use. This motor is on the only original A.S.L. axle, meaning it possibly may have been on longer than the others, although motor repairs are not necessarily related to axle work. The pinion is a Nuttall, a subsidiary of Westinghouse Electric.

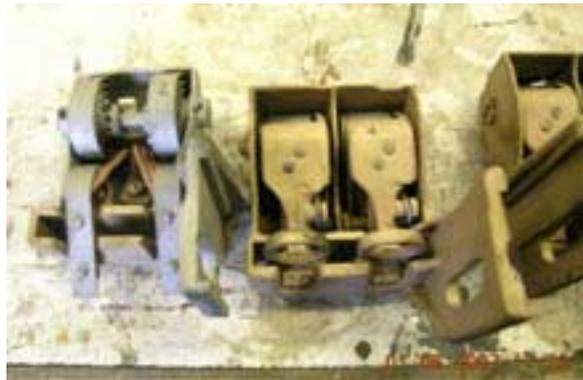
Brushholders – (8) All are in good condition. There are basically two different types, one being a later improved version. Five are the old style (two different types), one-piece cast bronze housing with music wire springs and loops for pulling the brush ‘hammers’ back. The other are malleable iron castings with a renewable brush box at the front. Because there is a certain amount of ash in a brush to control its hardness, this is abrasive and tends to wear the brush boxes to the point where the brush will rattle. This portion bolts on to the front of the main housing. The springs are of the ‘clock spring’ type—flat steel or phosphor bronze. All brushholders were sandblasted to clean them up. The malleable iron ones were then primed and finish painted with aluminium paint to keep them from rusting further. This was also done to the steel clock springs.

Generally the brushholders are in very good condition with all springs working and seem to have the correct tension. The housings have been subjected to various ‘episodes’ which have burned some holes in them but not enough to require repairs.

Clock spring an older type brushholders

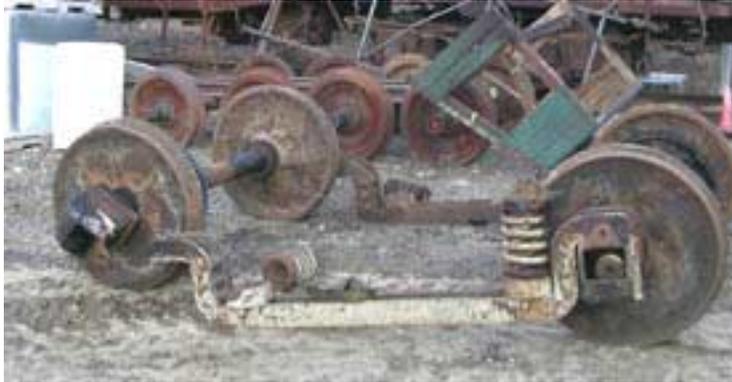
Equalizers, springs, journal boxes and wheel sets

Most of the equalizer coil spring sets came out of their bottom mounting ‘cups’ but several also were stuck with a major buildup of rust and required a bit of ‘persuasion’.

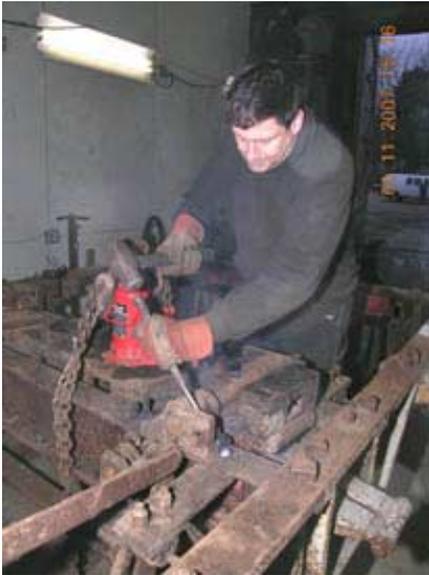
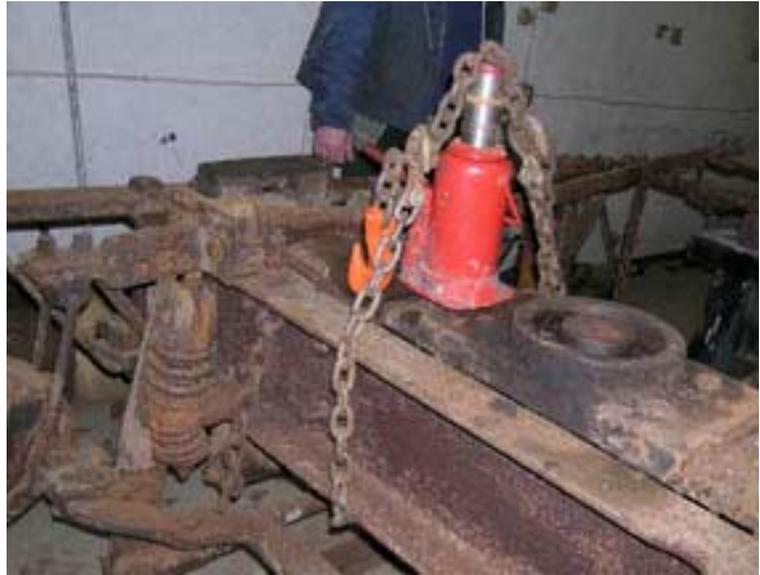
Randy Bogucki driving out swing link bracket bolt
Squeezing the bolster elliptic springs

To release the tension, it was necessary to make a loop of chain around the entire transom including a 20-Ton hydraulic jack resting on the bolster next to the swing link pin. On the first try, it didn't work well: the jack was low on oil so it didn't have much lift and nothing seemed to move anyway. The next try was more successful: better jack and some other assistance from another jack. Then the bolts which held the bearings for the swing link were cut, the jack released and *voila*, the spring was no longer under tension (or is it pressure?) There's nothing like experience because the other three sets came out in no time with minimal effort. Releasing and removing the springs also revealed a lot of things we really didn't want to see and which difficult, if not impossible to evaluate properly when the trucks were under the body.

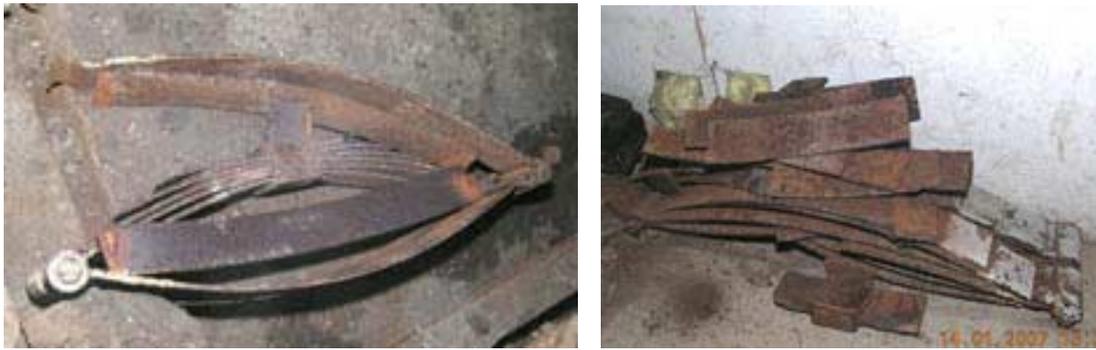
- Truck bolsters (1) seem to be in excellent condition with little corrosion. Center bearings look like new and there is virtually no wear anywhere.
- Double - Elliptic (bolster) springs (two sets) – Under each side end of the bolster are actually four springs making a double 'full elliptic' set. One spring arches up at the center and the other arches down, with the ends of each pair bent to form a 'football' shaped loop through which 'binding' bolts holds both pairs together. On our first inspection of the trucks, what little we could see of the springs was not encouraging and that was confirmed when the bolsters were removed. The springs on the no. 1 truck virtually disintegrated into a pile of barely recognizable scrap iron when they were removed. Corrosion had eaten away at the lower leaves and forced them apart, breaking the binding clamps. Those on the no. 2 truck have been released but not removed as yet, but possibly are marginally better.

Disintegrated elliptical bolster springs

Detail more on the elliptic springs – What was once a common spring, certainly found on many cars in our collection and other types of vehicles of the period. That is no longer the case. I called three companies in the Boston area who no longer do the work. Finally I called the company which made the new springs for 1160’s trucks in 1999: the Beall Manufacturing, Inc. of East Alton, IL. (618-259-8154) (FAX 618-259-7953) They still are willing and able to do so again and sent me a specification sheet for me to fill out giving the dimensions. One of these is the ‘loaded’ height. We really have no idea of what this was but can guess that it is probably about 1 in. less than the ‘free’ height.¹² The same goes for the length, which they call the ‘center distance’, free and loaded.
