Atlantic Shore Line Locomotive 100

Curatorial Report no. 8

10 September –16 December 2007

by Donald G. Curry, Shop Manager

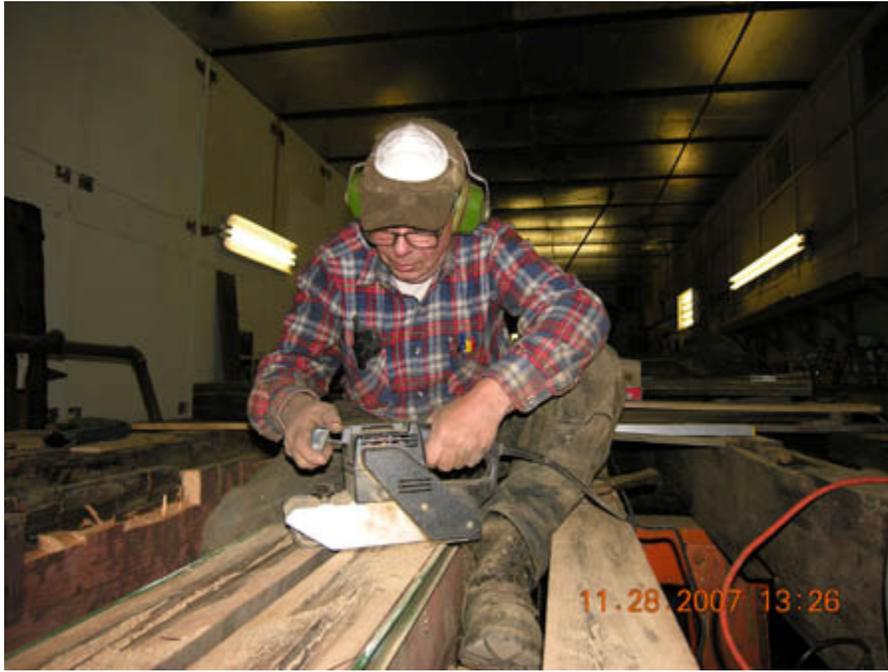
The ex I. S. M. belt sanding the cut-down sill tops

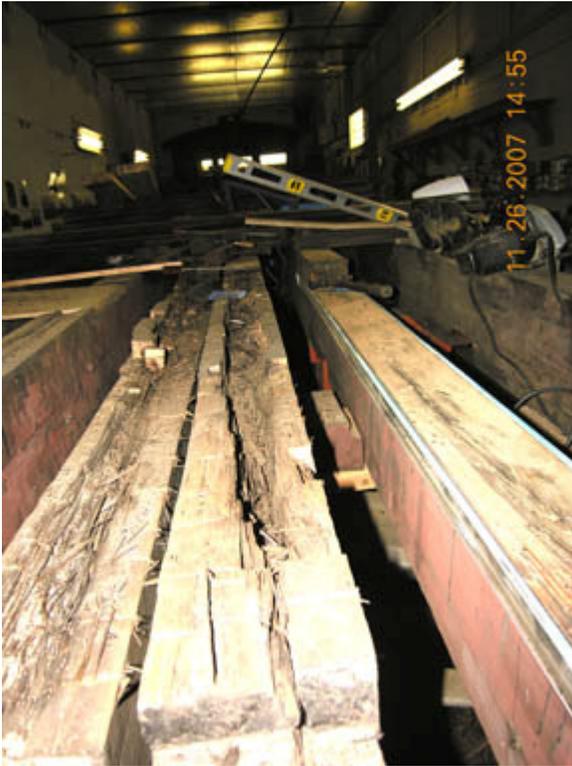
We found the undersides of several of these are also quite bad. No. 2 is rotted out in the center for about 1 ft. on each side of the bolster. No. 5 (it and no. 4 absorb the force of the coupler) suffered from longitudinal splitting, so we have chiseled and sawn off most of its bottom. At the bolster, under each of the eight sills, is a 2 x 8 notch for the bolster filler. These notches have 'eroded' upward at least ½ in. and some more than that, so we are chiseling and routing out an inch or more to get to a solid area to which we will epoxy 'new' wood. So far we have removed about 5 ash cans filled with chopped up rotted SYP from this end an amount which is about equal to that which we removed from the no. 1 end.

Sills 5 & 4 showing deteriorated areas

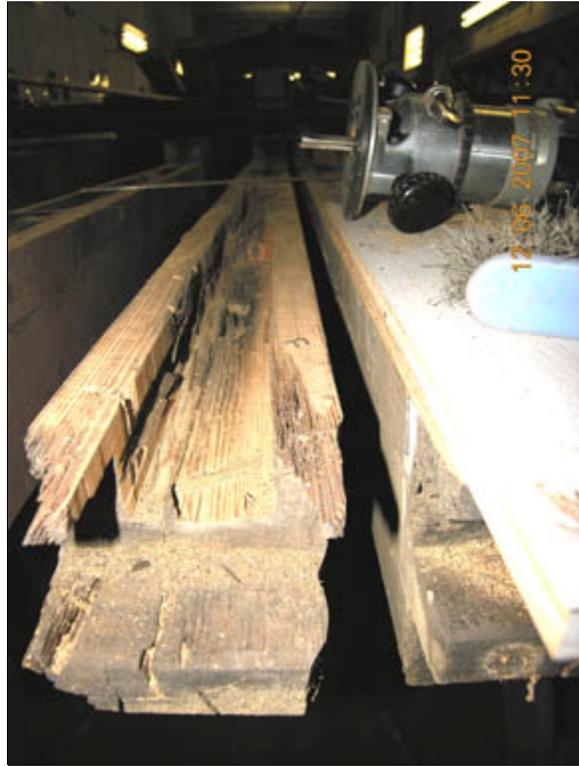
Sill 5 with rotted area routed out

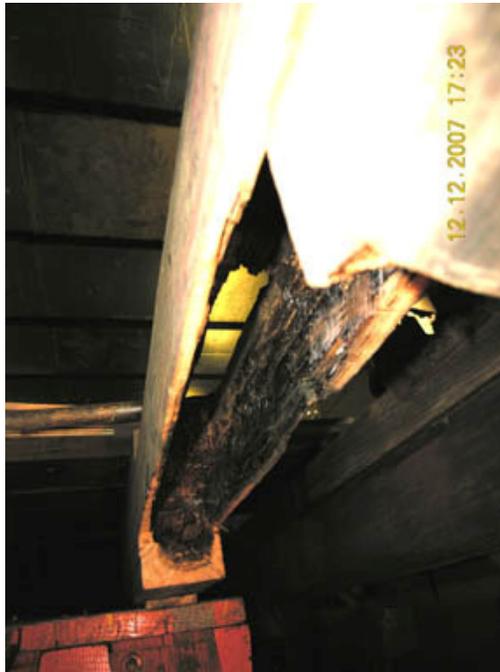
Preserving the integrity of the original sills - It was important that we not simply cut a sill all the way through because it would be extremely difficult to make any kind of splice that would hold, so we were careful to preserve enough of the original wood in each sill so it would ‘stand’ on its own. It is amazing how solid they were considering in sill no. 2 we had removed about 75% of its cross-section!

Sill 2 bottom after removing deteriorated wood

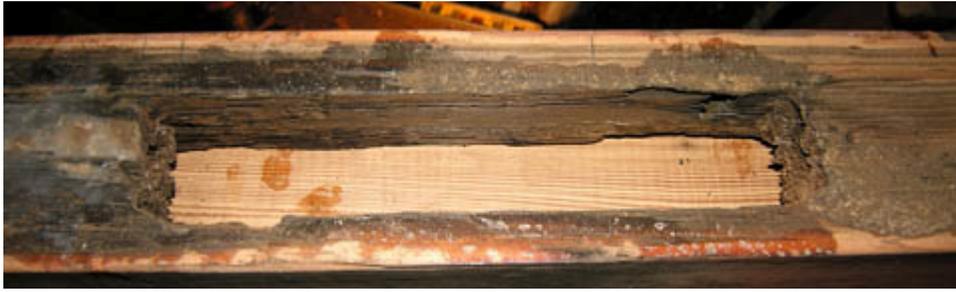
Sill 2 bolt hole area removed-new bottom installed

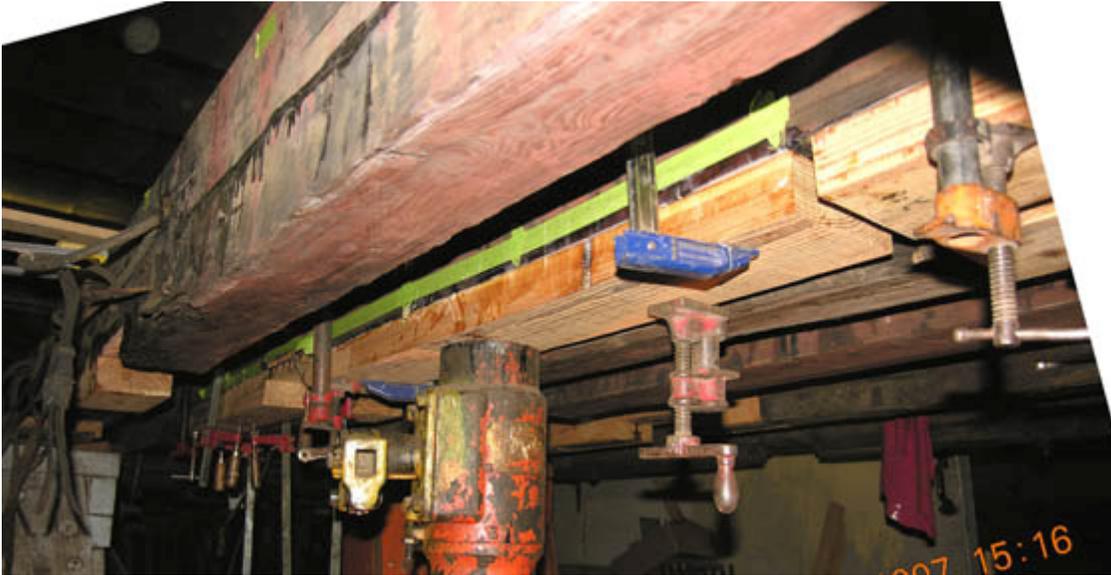
New sill bottom showing jack and many clamps

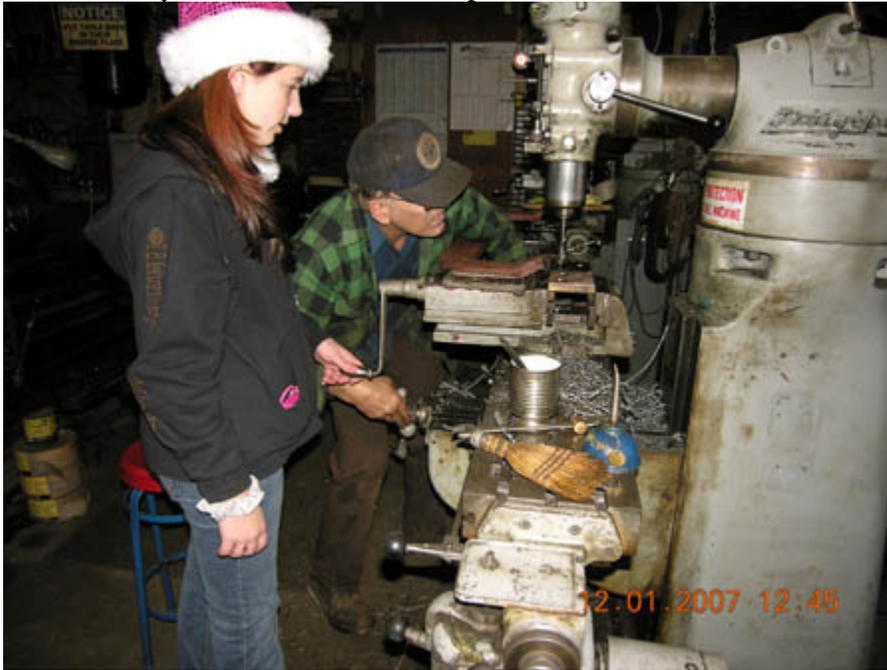
Truck work – Last year **Randy Bogucki** started replacing the corroded ends of the brake beams, but his new job with GE in Erie, PA, took him away. So **Dean Look** just completed the first pair. Because they were somewhat crudely forged by Laconia (or Alco), it was difficult for Dean to tell what original dimensions should

One of Santa's Elves (Chelsey Pino) watching Dean Look prepare to machine a new end for a brake beam
