**Atlantic Shore line Locomotive 100**  
**Curatorial Report no. 9**  
17 December 2007 – 13 January 2008

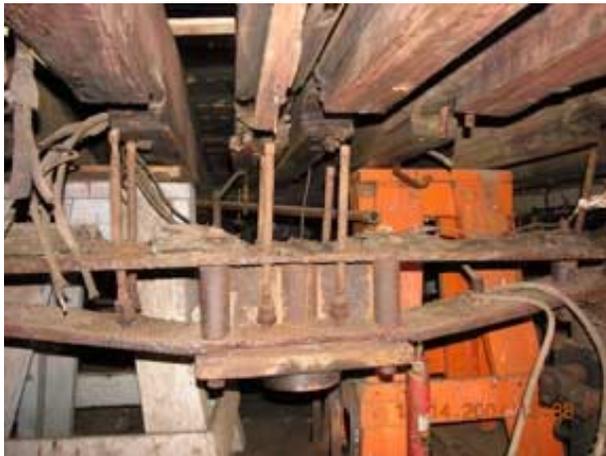
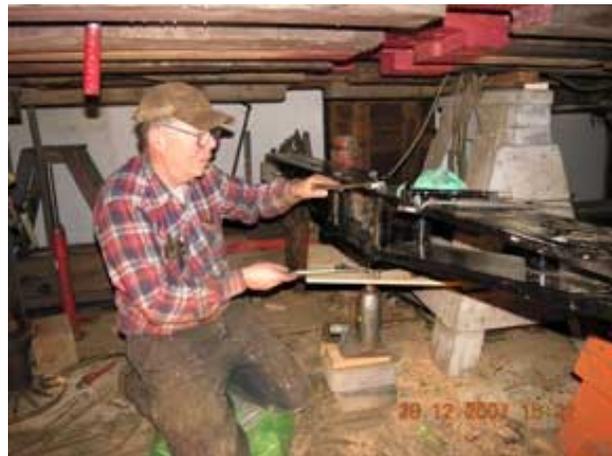
No. 2 end original bolster and Donald Curry installing new one

As we put them together we noticed that YUCo had installed shims between the side bearing castings, the center bearing and the bottom of the bolster frame. Those on the side bearings are rectangular pieces of steel about ½ in. thick. Over the center bearing the two pieces are strips of steel about 4 in. wide x 18 in. long with a large scoop out of each to make clearance for the king pin. We wonder why they felt they had to do this because the castings are shaped to 'surround' the bottom plate of the bolster? These ridges on each casting are about ½ in. high so, with the shims in place, the only thing which keeps these castings in place is the tightness of the bolts. Could it be the springs in the trucks or the wear of the wheels lowered the height of the couplers so they didn't meet those on freight cars properly?

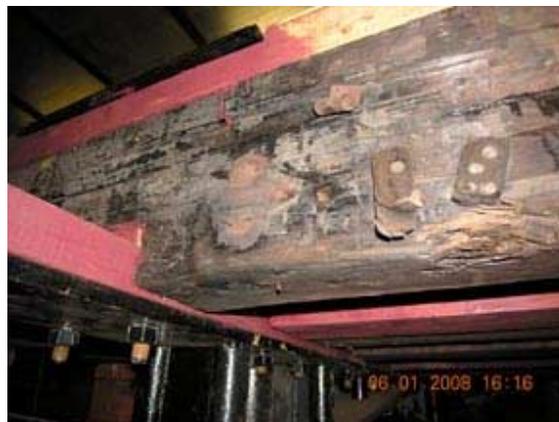
There is strong evidence of a wiring fire between sills 6 and 7 above motor no. 4. The surface of these sills was charred to a depth of about ¼ in. (The motor wiring in general seems to be a patchwork of spliced and friction taped bits, so there probably were other incidents of this sort that didn't get to the point of actually starting a fire.) Using the random-orbital sander with 60-grit paper this area was quickly sanded down to solid wood and given a coat of Cabot's stain.

Sill 6 showing charred area of wiring fire in motor no. 4 leads,

and remains of leather mounting straps for motor wires

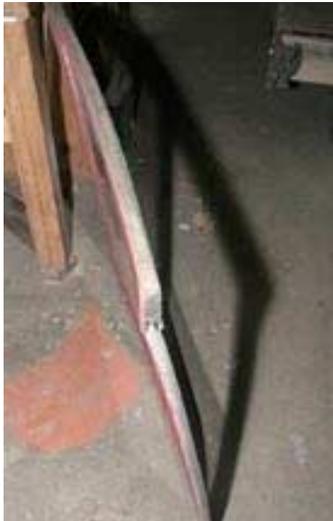
Bent cab sash

One of the side sash appears to have been a replacement. Whatever wood was used was certainly not kiln dried and has warped about 2 in. along the stiles (sides) (bow-shaped) from being straight. We will have to make a new sash in this case while the others appear to be salvageable.

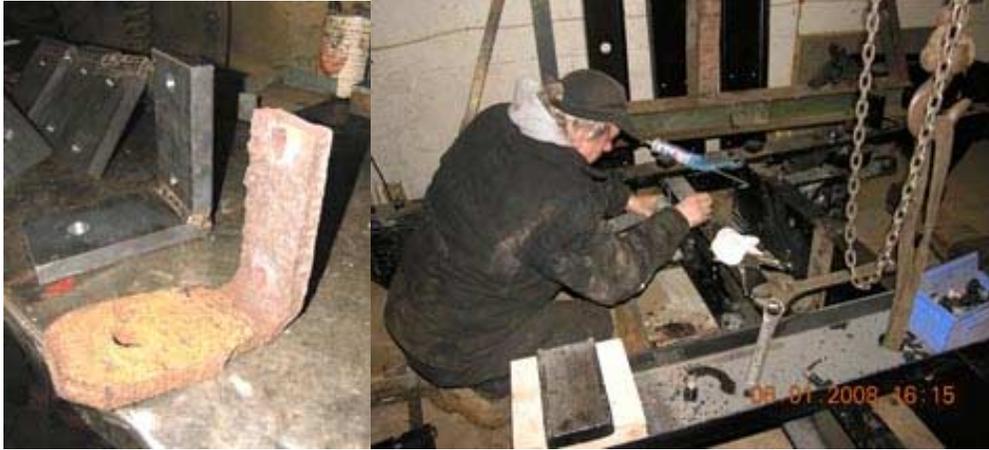
**Truck work** – **Dean Look** fabricated new motor mount angles to replace the eight originals that are badly rust-eroded. The original angles were bent from 1 x 4 in. bar in Alco's blacksmith shop, very likely using a steam or mechanically operated bulldozer. Dean joined these from two lengths of the bar by beveling one end of each piece and filling them with weld. **Chuck Griffith** trimmed off the corners of the angles and ground the welds. **Bill Pollman** and **Bert Rendall** primed and painted them. Bill is now fitting and installing them on the first truck. Dean fabricated eight motor mount bolts from  $\frac{3}{4}$  in. rod and square nuts. **Lloyd Rosevear** blasted them, preparing them for Bert to prime them.

Old and new motor mount angles (before trimming corners)  
Bill Pollman installing them on the truck frame

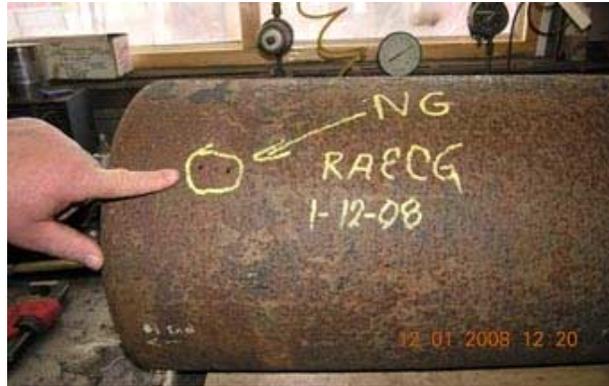
On 5 January they set up the high-pressure test pump and found it leaked to the point it required repacking and a new check valve. Fortunately it is a simple-minded device and was easy to fix. Main reservoir no. 1 passed at 185 lbs. (1.5 times the operating pressure of 110 lbs.) But on 12 January they set up the other two tanks for testing but before they even filled them with water, they found holes

in each. On both the failure was under where the supporting straps were—not an uncommon thing.<sup>4</sup> They also found that the auxiliary tank had been brazed in at least two places, not a good sign. Both tanks were unusable.

Holes in the main reservoir

So we set out to look at our large and varied supply of air tanks, scattered here and there on the grounds. Unfortunately many were buried in snow and all are in areas which make them subject to corrosion. We did find one 16 x 60 in. as a replacement for the secondary main reservoir. Fortunately there is room for the larger tank on the locomotive's left-hand side where there is only that tank. The auxiliary reservoir will be a very new tank, constructed in 1999. This tank was designed to be mounted to brackets welded to the tank but we plan to carefully remove them and return to the original strap style of mounting. Because there are two tanks on the right side there is limited room so it can't be any longer than the original 36 in. (The distance between the trucks is short. Given the poor conditions under which our spare tanks are stored, it's very likely many more of these tanks will fail their test. Thanks go to **Dan Cohen** for assisting in this search.

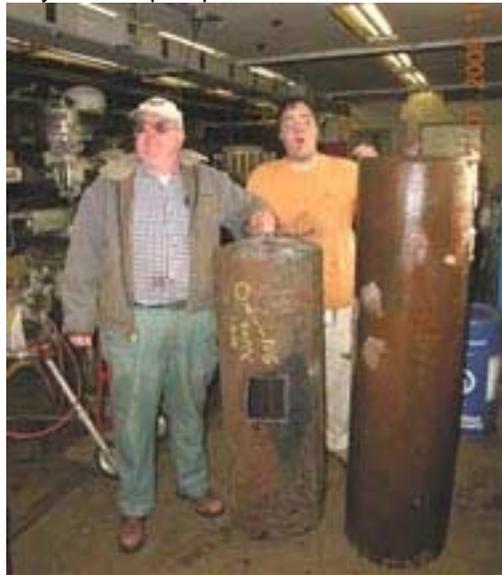
Dick Avy and Mark Sylvester with original main reservoir and replacement
