Atlantic Shore Railway Locomotive 100

Curatorial Report no. 13

24 July – 21 October 2008

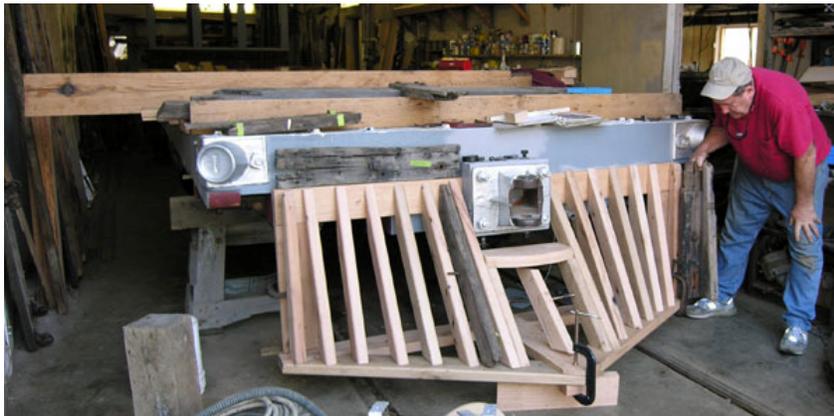
Jim Mackell & trial assembly, 9 October 2008

Jim fabricated all the pieces a bit long to ensure there is enough material for a proper fit when they are assembled. Using West System epoxy and sawdust filler, he has filled the voids in the recycled wood. These are the inevitable screw holes from their former 'life' and cracks that formed when it dried in its first use. One great advantage of recycled timber is its stability. It doesn't warp!

The next step will be to prime and paint all surfaces, especially the ends. It will be fastened together with 4 in. no. 16 galvanized slotted steel wood screws. The originals were not galvanized; hence most of them have disappeared long ago. In a 'curatorial compromise', where it's necessary, we favor longevity (preservation) over slavish accuracy.

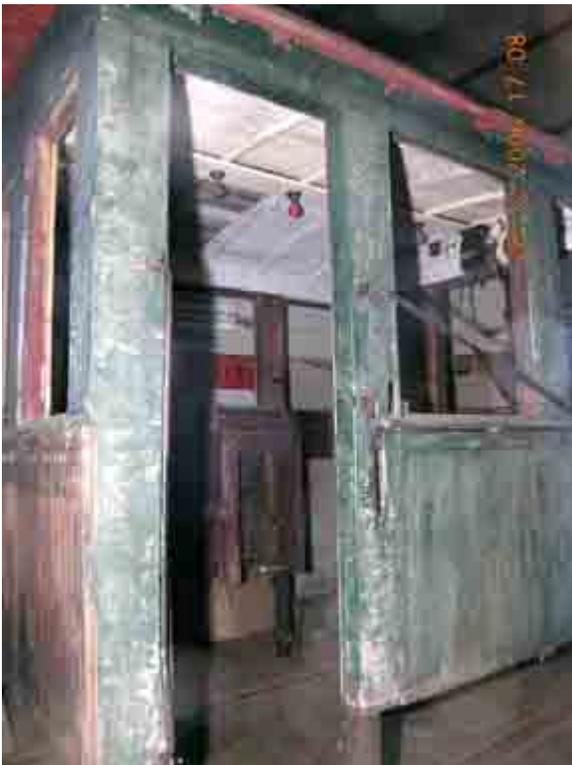
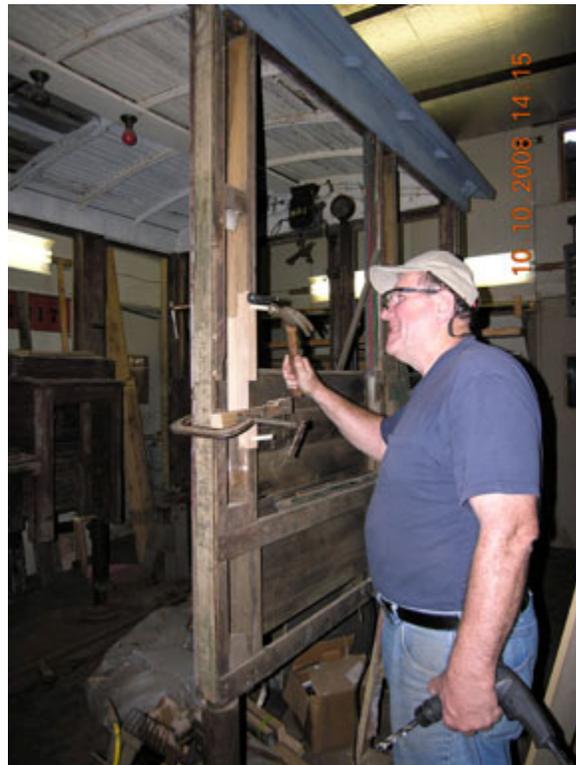
Cab repairs – The cab's woodwork, once you remove the many coats of paint, appears to be in good shape. There are only a few repairs that have to be made. Jim has already pieced in a new section of ash in the 'right-right door post. The right-hand belt rail (window sill) piece was about 2/3 original ash and 1/3 latter day pine. We'll replace it with a new one 100% ash. There are a couple of other defects that can be patched with small pieces of wood and/or epoxy.

He is in the process of repairing some small rotted areas around the right-hand doorway. There he pieced in new ash.

There are two poplar facing of the posts which need patching or replacement. We purchased a piece of poplar from Deering lumber from which Jim will piece in what is needed. Before any is put on, the many oversized nail holes will have to be filled. Jim also found in stock sufficient 5/4 poplar to do the job.

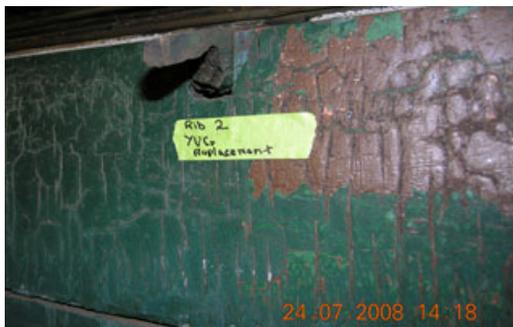
Layer 2. Thick layer or layers of a nut brown. This seemed to have been the heaviest layer and probably had been repainted. It's not pretty but it is quite utilitarian. Because of the relationship of these layers and their thickness, we feel this is the color that 100 had during the period to which we're restoring it.

Brown layer over sash
