THE NEW ENGLAND ELECTRIC RAILWAY HISTORICAL SOCIETY
Seashore Trolley Museum & National Streetcar Museum at Lowell

VOL 65, NO 1
January - March
2022

Dallas 434

MAJOR OVERHAUL

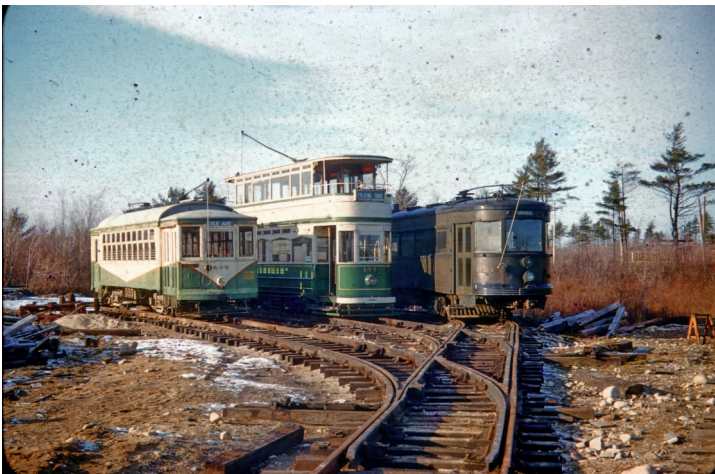
In 1955, after reassembly of the track fan from North Point Carhouse in South Boston, three new arrivals at Seashore pose on the tracks soon to be covered by South Boston Carhouse. From left to right: Dallas 434, Blackpool 144, and Montreal & Southern Counties 621

Volunteers constructed the carhouse served by this track in the 1956 to 1958 period. The design consisted of four lines of wooden phone poles topped with wooden truss pieces and a corrugated metal covering. Insufficient funds prevented covering the sides, so protection from the weather was limited.

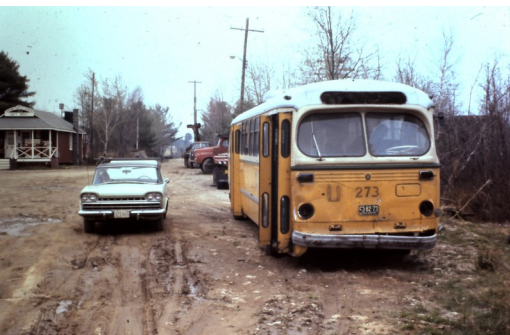
Halifax No. 273 at the Seashore Trolley Museum, May 1971. Photo: Russ Munroe.

No. 273 is currently stored outside Central car barn (pictured below). It is in fair condition and in need of various repairs.

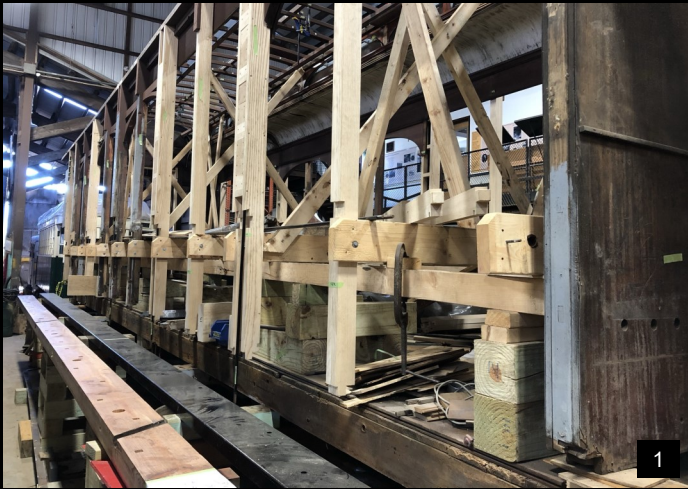
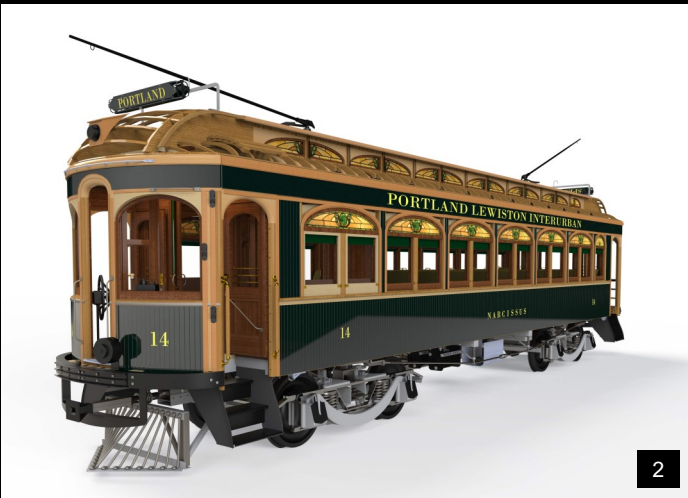
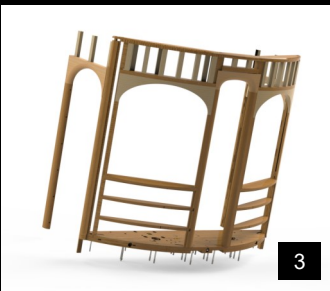
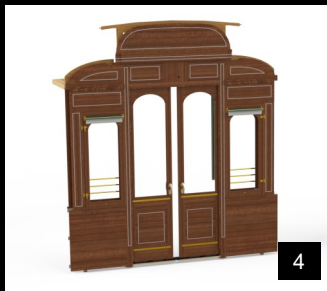
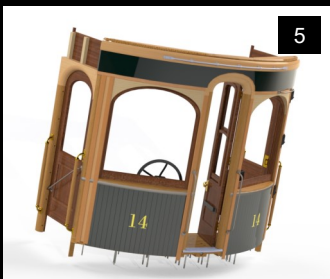
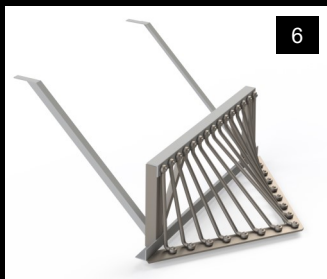
1. One side sill and matching steel channel sit adjacent to The Narcissus restoration; Seashore Trolley Museum collection.

2-6: Renderings from Solidworks, photos by Ernie Eaton. 2. The complete car with some roof ribs exposed. 3. Vestibule frame with the trim and siding hidden to expose the frame structure. 4. The vestibule bulkhead, as viewed from inside the compartment. It's a subassembly made up of 385 components. 5. Vestibule structure forward of the bulkhead including doors and windows. 6. The fender is a fairly simple subassembly.

One of the truly important tools that Ernie Eaton, the restoration shop project manager overseeing all aspects of the restoration of the *Narcissus*, is utilizing, is Solidworks software. Since fall of 2017, as a personal effort, Ernie Eaton has been capturing a three dimensional computer model of *Narcissus'* wood and steel structure using a student license of Solidworks 3D modeling software. In December of 2020, Dassault Systemes granted the museum several commercial licenses for their Solidworks software suite. Since then Ernie has continued the *Narcissus* effort, and the software has been used by both Ernie and Brian to produce software models of casting and wood structures required for other projects as well.

Over the years each unique wood and structural metal part of *Narcissus* has been measured and then described to Solidworks producing many part files. Even the interlocking rubber floor tiles were modeled. These files are then used to "build" computer based assemblies such as the frame, vestibule structure, walls and roof. These assemblies come together to produce a model of the entire car that captures its entire design. Using Solidworks Visualize, these computer models have been used to generate (render) image files of the view desired. Multiple images can be combined to form videos, and more complex renders can produce stereoscopic, 360, and 360 stereo views which bring the model to life. When rendering, paint and gold leaf can be removed to view the materials beneath. Parts can be temporarily removed, or cross section views produced to reveal the inner workings of the car's structure. Most of these views could never be captured using the physical car. We expect that these images and videos will eventually be used to tell the story of the car's construction in a display at the museum. It should also provide future generations of researchers a unique ability to see into the structure of this 1912 luxury coach. The *Narcissus* model was recently enhanced with details revealed during the disassembly of the #2 vestibule allowing mechanical drawings that aid in the understanding and fabrication of missing or damaged parts. You can see an animated short video from early in 2020 here: <https://youtu.be/FcIGGfBGDRA>

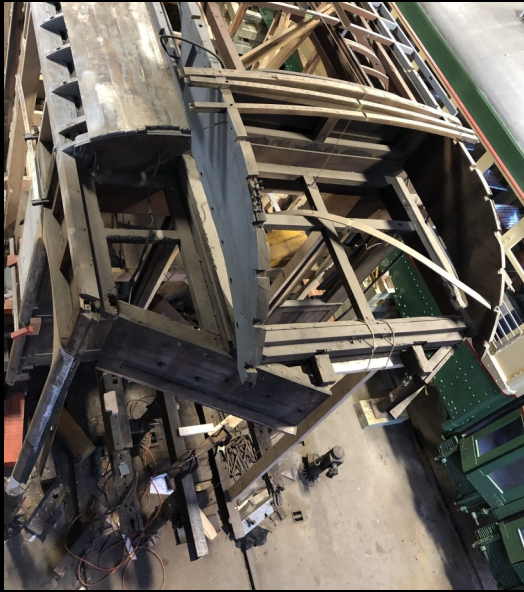
Major structural work to the car's vestibules has begun. Seashore Trolley Museum collection

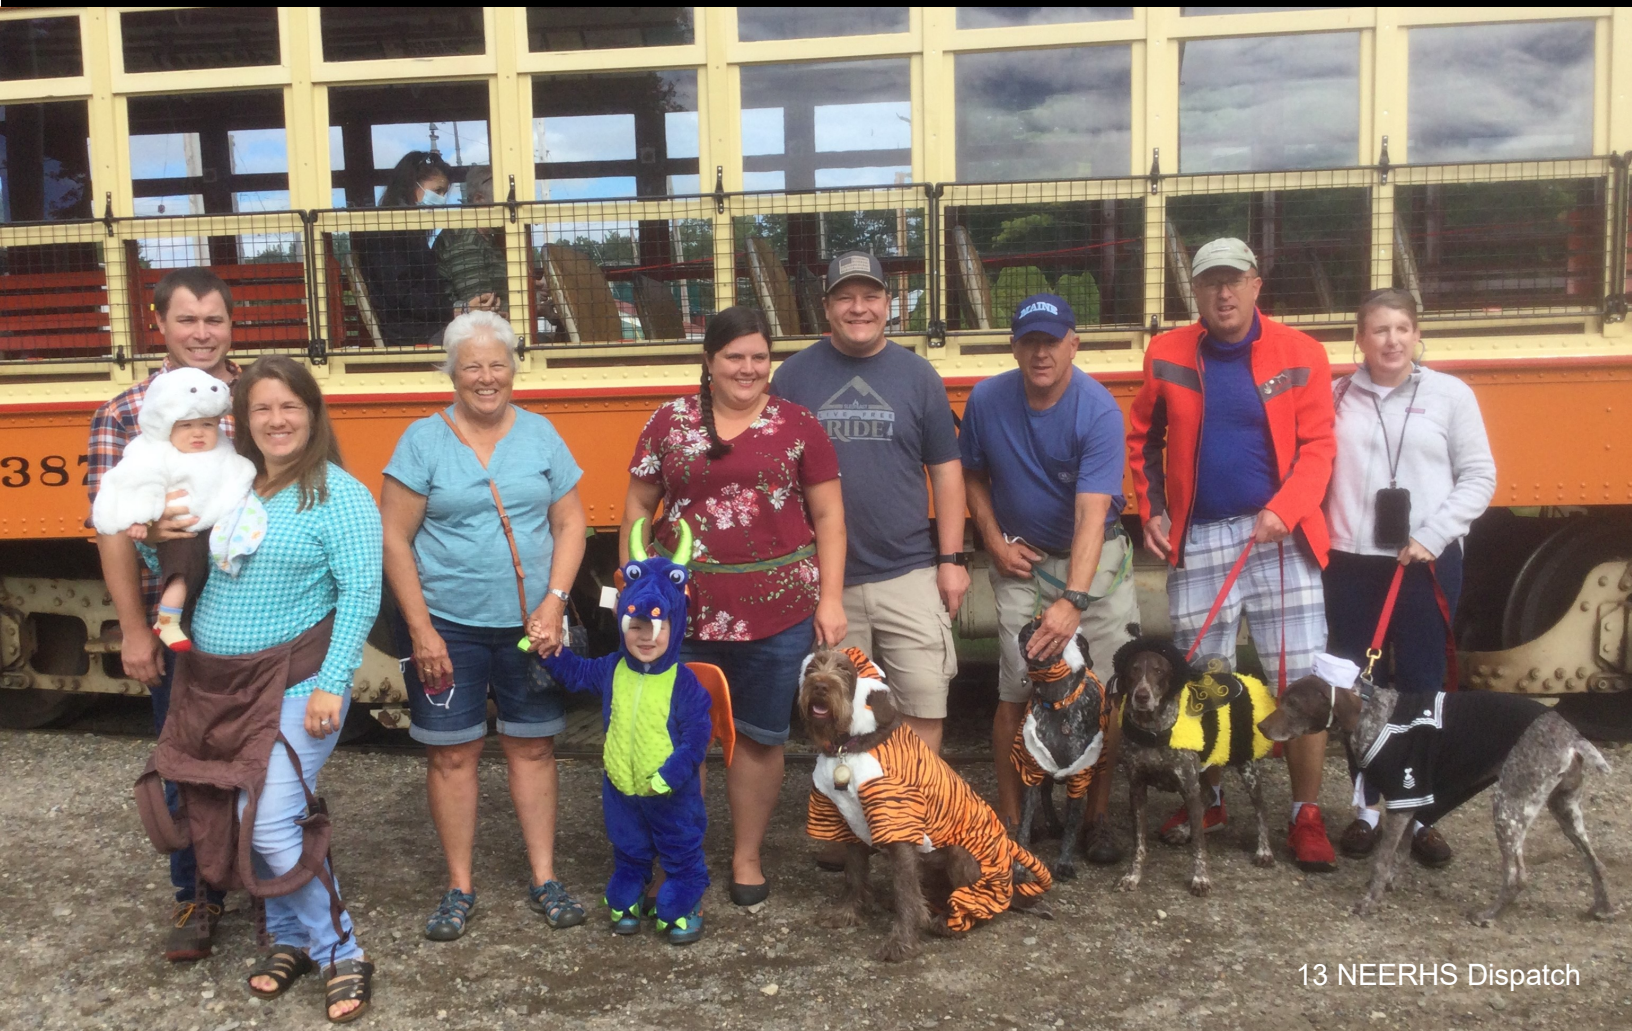
Volunteer Nick Ouellette removing the trolley pole hook from a badly deteriorated piece of roof board.

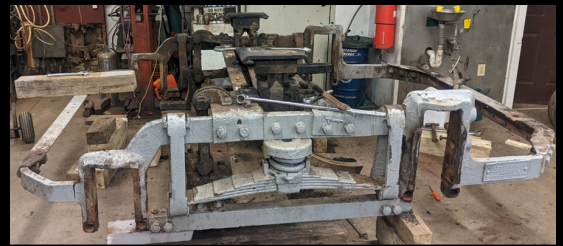
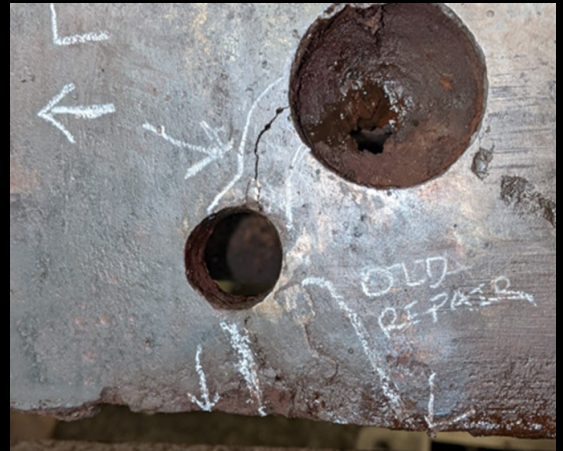
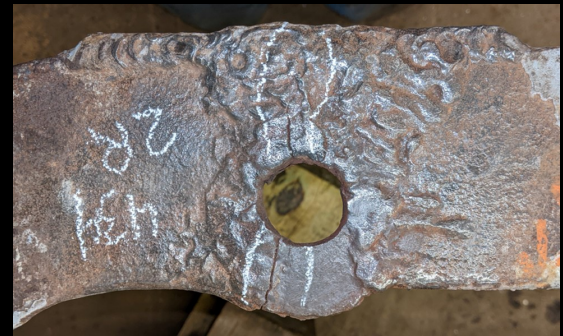
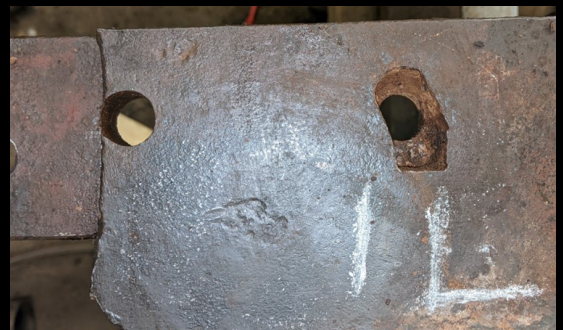
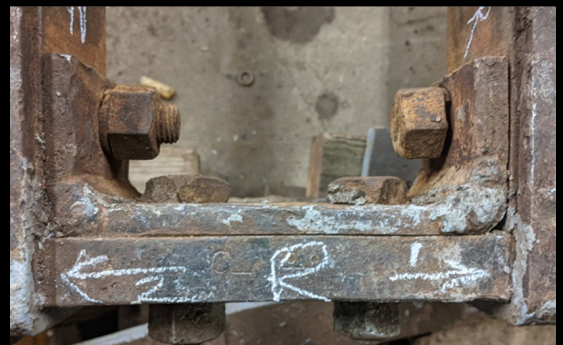
Many of the parts were heavily caked with dirt and petrified oil and required numerous cleaning efforts. Significant and unusual wear was noted on the journal boxes and some of the brake components.

Upon removal of the center bearing casting, it was discovered that the truck bolster was cracked in several places. These defects are completely invisible when the bolster is assembled. The driver end frame of the truck was found to be cracked in numerous places around the holes for the motor suspension bolts. Past assembly errors resulted in heavy wear to the inside face of the end frame from the motor suspension springs. This component appears to have been repaired at least twice.

Repair issues: The truck was damaged significantly enough that major components had to be repaired or replaced. While some of the repairs are neat, others are quite shoddy, and some replaced parts were clearly made from scrap. The brazing on the wear liners also suggests a "get it done" repair mentality. The truck also appears to have been repaired more than once.

From top to bottom: #1 truck partially disassembled; detail of bolster cracks; cracked end frame, right side; "re-made" gusset plate; repairs on the transom brace, indicated bolt was loose. BT

- Repairs to worn surfaces inside journal boxes and on truck frame
- Straightening truck frame and replacing parts as needed
- Production of new wear liners
- Repair/replacement of journal bearing shells
- Design of brake shoe heads
- Repair/replacement of brake rigging components
- Repair/replacement of swing hangers and associated hardware
- Replacement of worn pins and bushings
- Addressing the issues with the carbody bolster and the surrounding structure
- Painting and reassembly

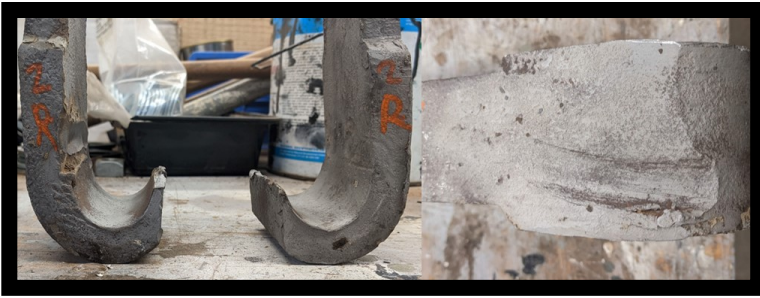
The suspension consists of the truck bolster, which bears on a coil and leaf spring. The bolster has to be able to move up and down, as well as swing side to side, relative to the truck frame, as the car runs. The side to side motion in a Brill 39E is allowed by the loop-shaped swing hangers, pictured here, at each end of the leaf spring. These hangers transfer the load from the bolster springs to the

truck frame, and the truck frame bears on the journal boxes through another set of coil springs. 434's #1 truck was found to have three of the four swing hangers backwards, with attendant scraping and damage on the inboard faces of the swing hangers from the wheels and brake rigging (also pictured). The truck frame was also subjected to heavy wear at the swing hanger bearing surfaces. Interestingly, several historical pictures of sister cars in Dallas show similar issues with swing hanger assembly, and the #2 truck in 434 is assembled improperly as well.

Following these measurements, the truck frame was sent to AC Electric for sandblasting. When it returns, the pedestals will be straightened and the damaged parts replaced. The swing hanger bearing surfaces will also be built up where needed. The cracked bolster was brought to the Grafton and Upton Railroad for repair. After sending these parts out, work turned to designing and prototyping parts for the journal boxes.

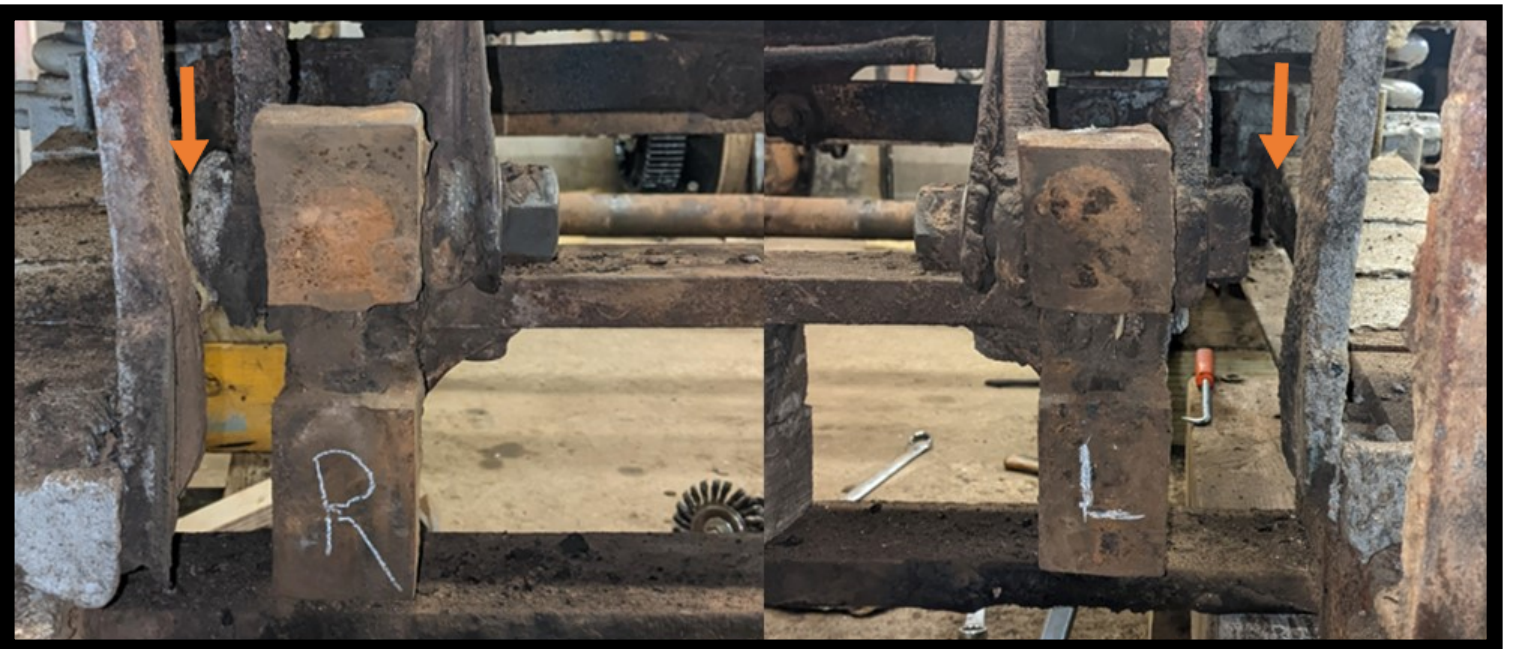
To help further define how the truck frame is bent, a laser level/square system was used. This device emits self-leveling vertical and horizontal beams, which can be aimed at various points to check for squareness. The position of the beam can also be measured relative to a surface with a tape measure. While none of these features are unique to the laser, it provides an easy, accurate way of taking measurements that would be more difficult to take otherwise.

The truck frame was first leveled and its centerlines established. The laser was then used against these references to take various measurements. The laser was also used on the pedestal surfaces directly to check for alignment. The laser was “shot through” several holes to check for alignment as well.

These measurements indicated, from the perspective of an operator at the #1 end of the car, that: the forward pony pedestals were significantly bent to the right and that these were the worst bent in terms of inboard/outboard; the pedestal surfaces were generally square fore/aft; the left sideframe led the right sideframe slightly; the tops of the sideframes were not at the same height; the sideframes were the same distance apart but the centers of lines through corresponding points were not on the drawn centerline; and the driver endframe was significantly twisted as well as bent.

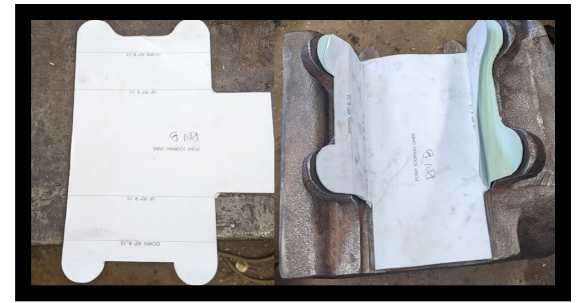
The wear liners for the journal boxes were verified using “Cardboard-Aided Design” (see photo above). The original wear liners were measured and the measurements were used to create 3D models. Using the sheet metal features in Solidworks, these models were flattened into patterns, which were then printed out full-scale and glued onto a piece of tagboard. The parts were cut out with scissors and bent on the indicated lines with the Shop’s sheet metal brake. The resulting parts were then checked against the journal boxes for fit. Any revisions could then be quickly checked for minimal cost. The verified designs are being sent to Don’s Sheet Metal in Biddeford for prototype and eventual “full-scale” manufacturing; using CAD also simplifies interfacing with the CNC machines found in most industry and helps to streamline the manufacturing process.

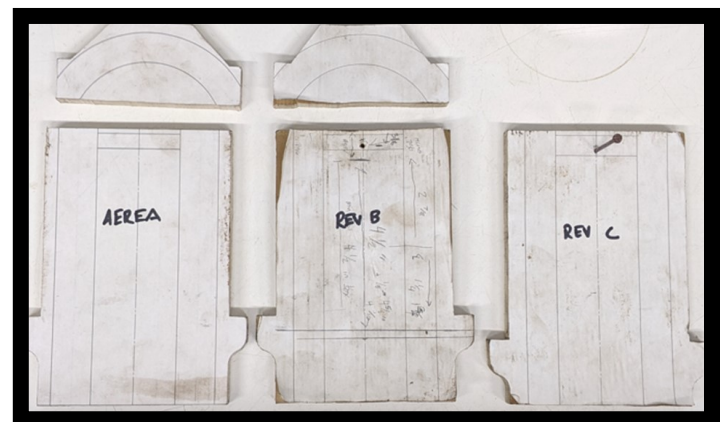
Three design revisions for driver journal bearing. BT

As noted, drawings for the journal box wear liners were not available, and issues with modification of the journal bearing shells had already caused alignment issues in the truck. Manufacturing any prototype is expensive, but new designs need to be verified before they can be produced. The cost of mistakes or oversights can become very high, particularly if the project moves into production before these issues are caught. These issues become more serious for small production runs, so it is important to verify designs as far as possible before committing to (i.e. paying for) production.
