Atlantic Shore Line
Locomotive 100
Curatorial Report no. 2
1 – 16 January 2007
by Donald G. Curry, Interim Shop Manager
Seashore Trolley Museum

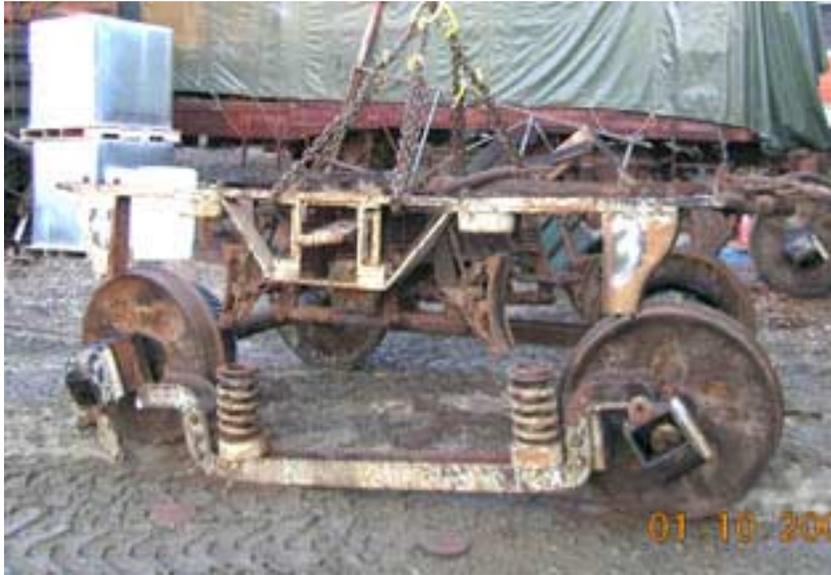
Lifting the truck frame

Most of the equalizer coil spring sets came out of their bottom mounting ‘cups’ but several also were stuck with a major buildup of rust and required a bit of ‘persuasion’.

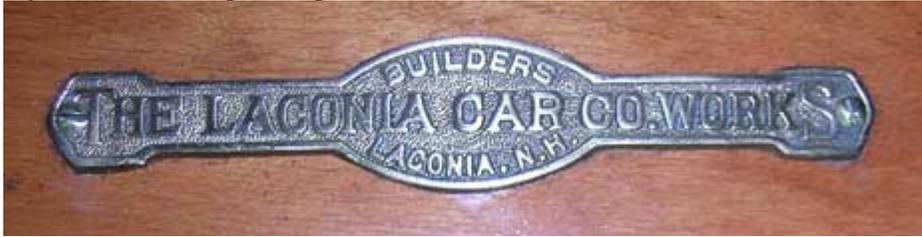
Missing builders plate

While looking at replacing the deteriorated leather hand straps in Manchester car 38, I happened to notice its beautiful Laconia Car Company builders plate obviously missing in 100. (Only its outline shows now.) Does anybody have one they would like to put on permanent loan in 100?
