**Atlantic Shore line Locomotive 100**  
**Curatorial Report no. 9**  
17 December 2007 – 13 January 2008

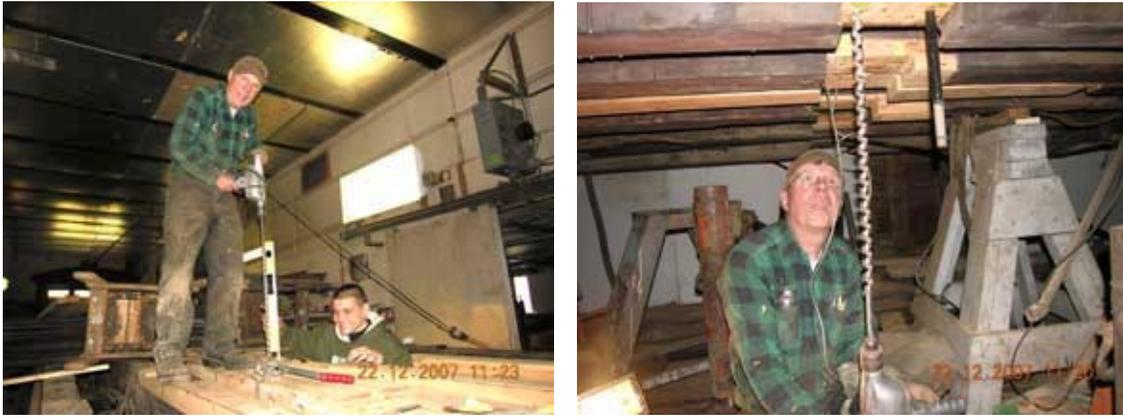
<sup>1</sup> The original bolsters were so badly corroded, it was impossible to get an accurate layout of the holes, we could only guess where they were.

Drilling for bolster bolts with help from Brendan Barlow

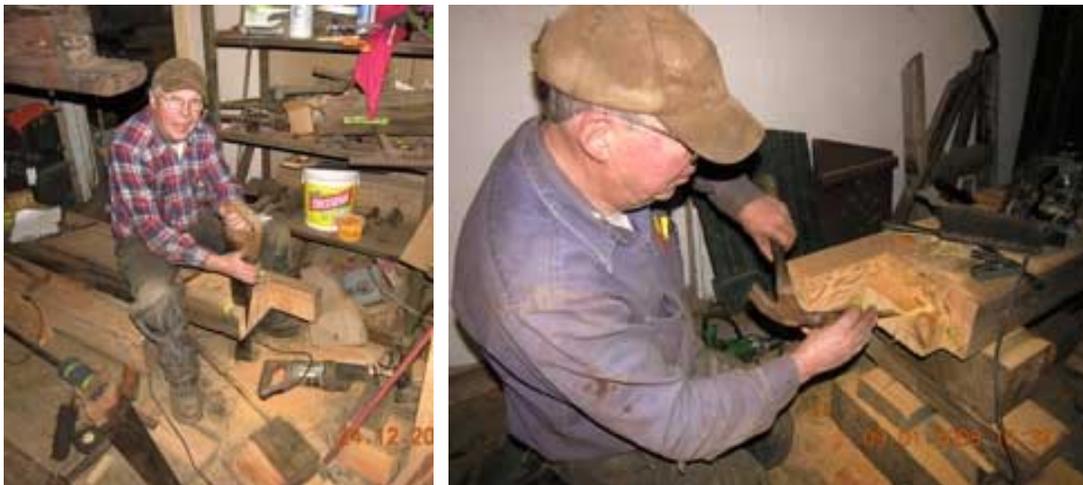
Forming ends of the long sills

This involved cutting with the coarse saw followed by some ‘trimming’ with the very coarse belt sander.

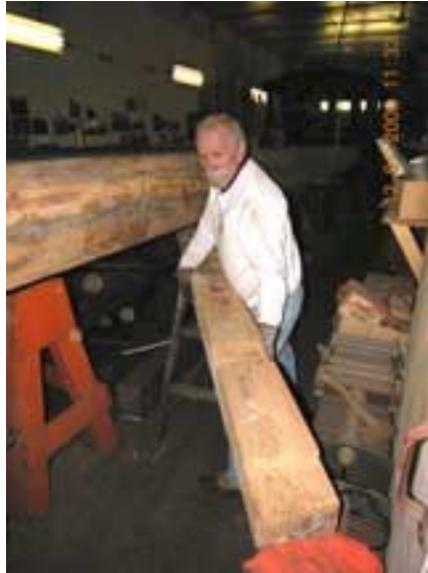
Fred Poore installing needle beam

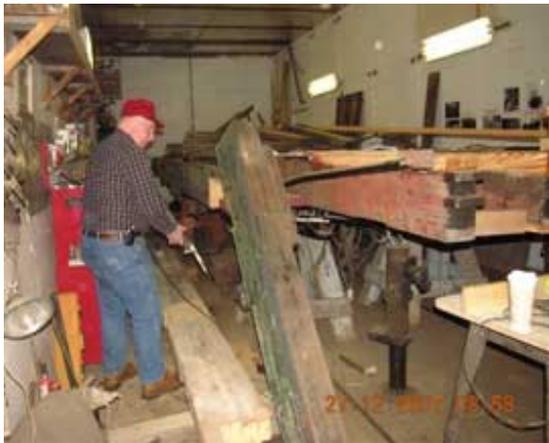
However, first the old sills had to be removed. Fortunately **Paul Cronin** arrived right in time to do the necessary bull work. There were a number of bolts that required the use of the Sawzall, then driving out to be turned into no. 1 scrap. He cut the no. 1 (original) sill into ‘bite-sized’ chunks about 8 ft. long so they could be taken out.

Paul Cronin cutting off old sill

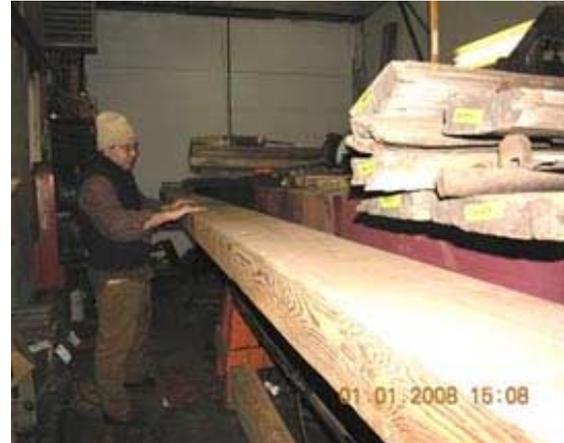
Randy Leclair with ready to upright new sill no. 1

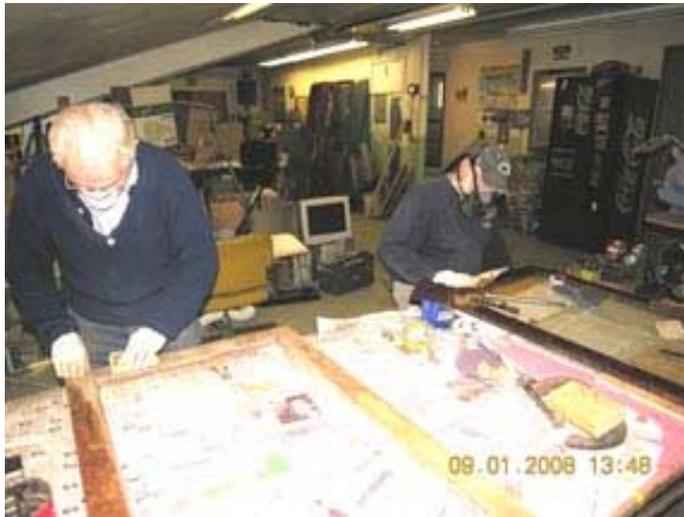
Bob Reich & John Fatula scraping cab end sash

The wood appears to be cherry but it's hard to tell. What I have seen looks as if they used the light coloured sapwood that they would not use in a passenger car. It's very hard to tell what the color was originally and we couldn't afford another colour match. What they have found under the present very deteriorated barn (or tile) red is brown, green, white, black, *etc.* Possibly the sash was originally varnished but, since we're going for the 1930s era, we're going to use a barn red enamel, inside and out.

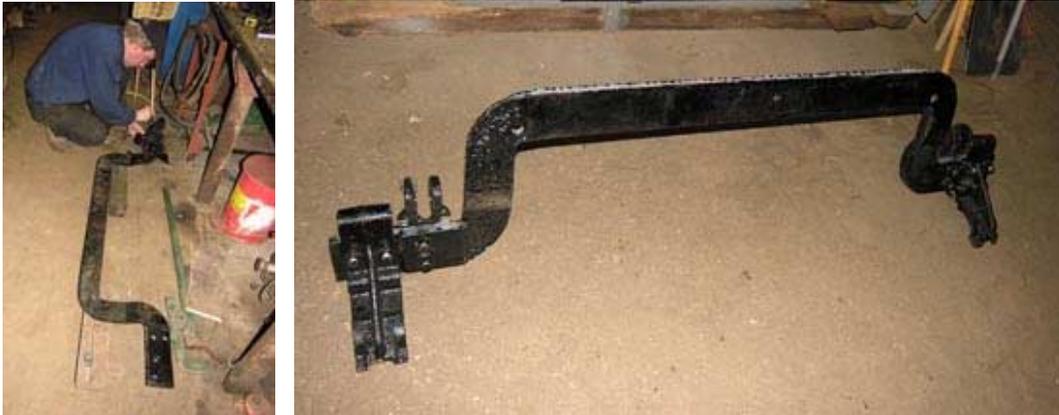
Bill Pollman installing brake shoe head on rebuilt brake beam

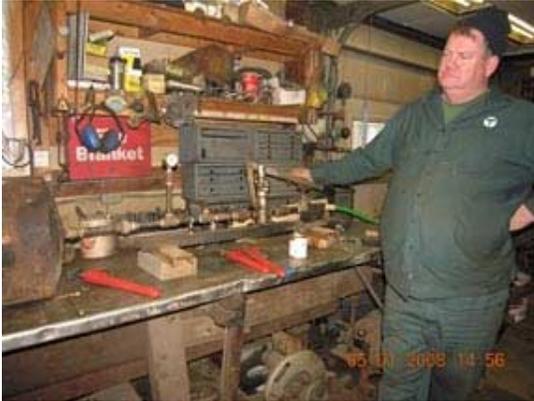
On 5 January they set up the high-pressure test pump and found it leaked to the point it required repacking and a new check valve. Fortunately it is a simple-minded device and was easy to fix. Main reservoir no. 1 passed at 185 lbs. (1.5 times the operating pressure of 110 lbs.) But on 12 January they set up the other two tanks for testing but before they even filled them with water, they found holes

in each. On both the failure was under where the supporting straps were—not an uncommon thing.<sup>4</sup> They also found that the auxiliary tank had been brazed in at least two places, not a good sign. Both tanks were unusable.

Chuck Griffith with hydro-test pump

So we set out to look at our large and varied supply of air tanks, scattered here and there on the grounds. Unfortunately many were buried in snow and all are in areas which make them subject to corrosion. We did find one 16 x 60 in. as a replacement for the secondary main reservoir. Fortunately there is room for the larger tank on the locomotive's left-hand side where there is only that tank. The auxiliary reservoir will be a very new tank, constructed in 1999. This tank was designed to be mounted to brackets welded to the tank but we plan to carefully remove them and return to the original strap style of mounting. Because there are two tanks on the right side there is limited room so it can't be any longer than the original 36 in. (The distance between the trucks is short. Given the poor conditions under which our spare tanks are stored, it's very likely many more of these tanks will fail their test. Thanks go to **Dan Cohen** for assisting in this search.
